# Manhole Inspection Summary

Manhole # S25I\_\_028MH

Insp Date: **1/14/09 9:20 AM**

**Location** Address: **1120 W LOMBARD ST**

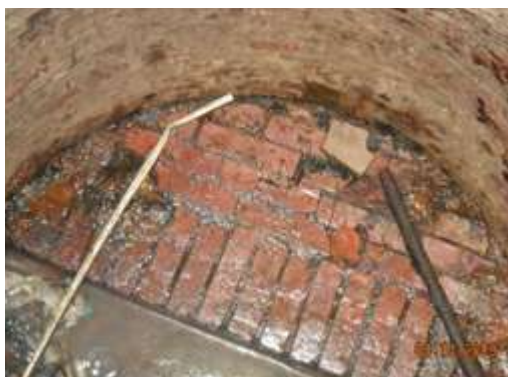
Misc

**Channel** Material: **Brick** ☐ Parged  
Channel Exposure: **Fully Open** Junc Dist: **0** nearest .5 ft. Azimuth: **0**  
Condition: ☐ Sound ☐ Cracked ☐ Root Intrusion ☐ Deteriorated ☐ Leaks ☒ **Debris**

DEBRIS ON BENCH

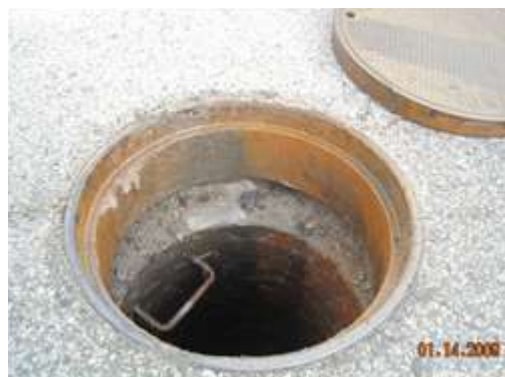
MISC.

**Manhole** Type: **Junction** Location: **Roadway** Ground Conditions: **Dry**  
☐ Prev. Rehab Weather: **Dry** Subject To Ponding: **Sheeting**

INFLOW EVIDENCE FROM SHEETING

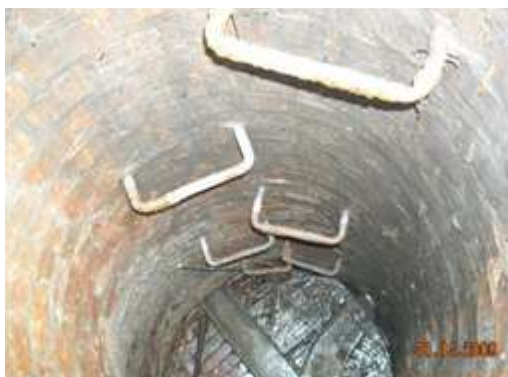
Defect 4

**Steps** Count: **6** Missing: **0** ☒ **Corroded**

CORRODED STEPS

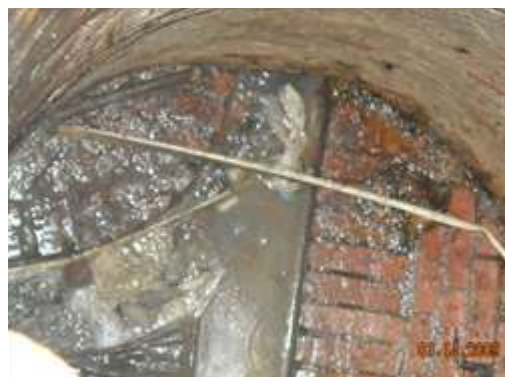
Defect 3

DEBRIS IN CHANNEL

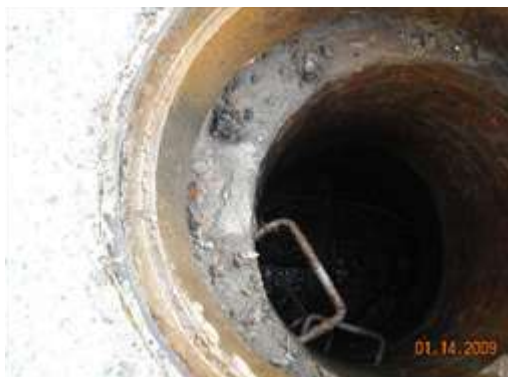
### Defect 1

**Frame** Offset: **7** (in.) Condition: ☒ Sound ☐ Cracked ☐ Leaks

FRAME OFFSET

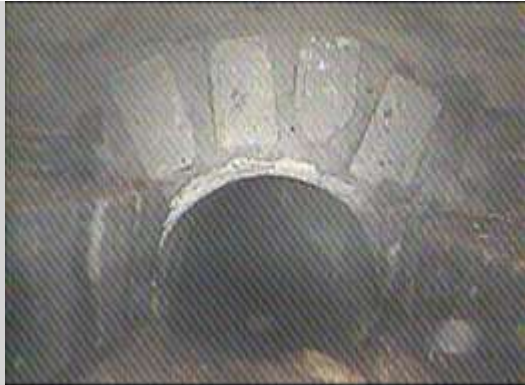
12 O'Clock Outflow

8 in. Circular Gravity Sewer  
Pipe Out @ 12 O'Clock

Pipe Height: **8.4** (in.) Rod and Bar (Angled)  
Pipe Material: **Clay** ☐ Pipe Lined  
Invert Depth: **10.80** (ft.) Flow Characteristics: **Slow**  
Deposits: ☐ None ☐ Mud ☒ **Sludge** ☐ Debris ☐ Grease  
Silt Depth: **1** (in.) Deposits Extent: **Light**  
Infiltration: **None** Pipe Seal Cond: **Sound**

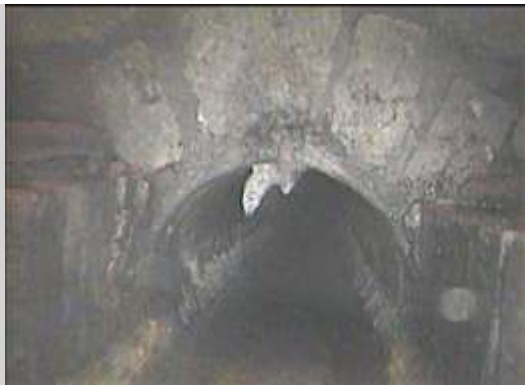
6 O'Clock Inflow

8 in. Circular Gravity Sewer  
Pipe In @ 6 O'Clock

Pipe Height: **8.4** (in.) Rod and Bar (Angled)  
Pipe Material: **Clay** ☐ Pipe Lined  
Invert Depth: **10.70** (ft.) Flow Characteristics: **Slow**  
Deposits: ☐ None ☐ Mud ☒ **Sludge** ☐ Debris ☒ **Grease**  
Silt Depth: **1** (in.) Deposits Extent: **Light**  
Infiltration: **None** Pipe Seal Cond: **Sound**

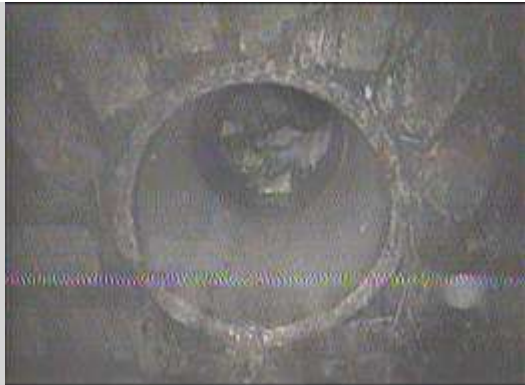
Pipe In @ 9 OClock

Deposits: ☐ None ☐ Mud ☒ **Sludge** ☒ **Debris** ☐ Grease

Silt Depth: **3** (in.) Deposits Extent: **Medium**

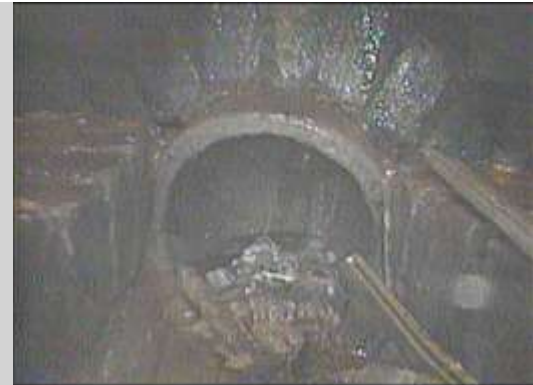
Drop In @ 9 OClock

Drop: **Outside** Rod and Bar

Drop Condition: **Partly Clogged**
